Manhole Inspection Summary

Manhole # S71G1_003MH

Insp Date: **12/17/08 2:25 PM**

Location Address: **Ralls Ave.**

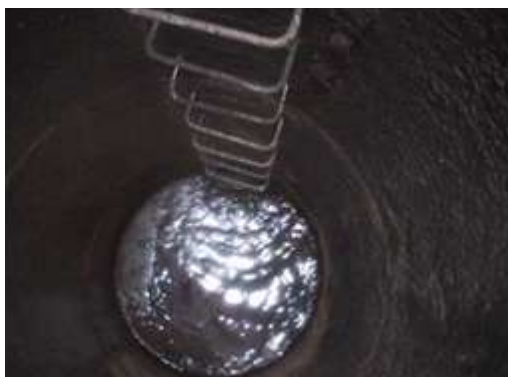
Comments **INSPECTED 12/17/2008. MANHOLE STARTED TO SURCHARGE WHILE WE WERE THERE DOING THE INSPECTION. FRAME OF MANHOLE COVER BROKEN.**

Active Surge starting

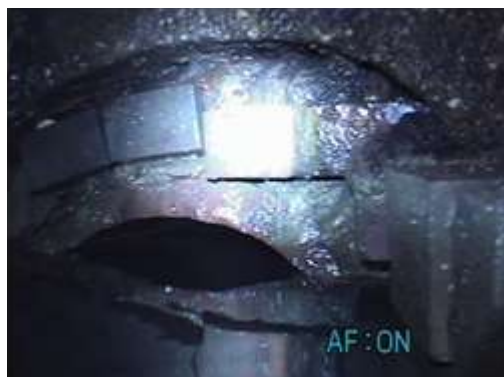
Defect 1

Missing mortar and bricks above O12

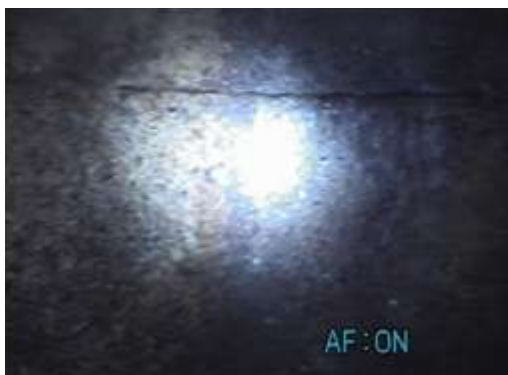
Defect 5

Crack in precast waall

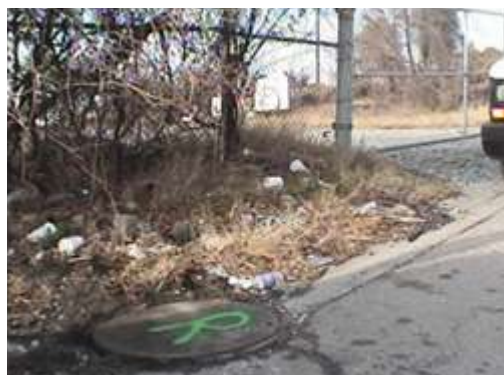
Defect 6

Frame Offset: **0** (in.) Condition: ☐ Sound ☒ **Cracked** ☒ **Leaks**

broken frame around manhole

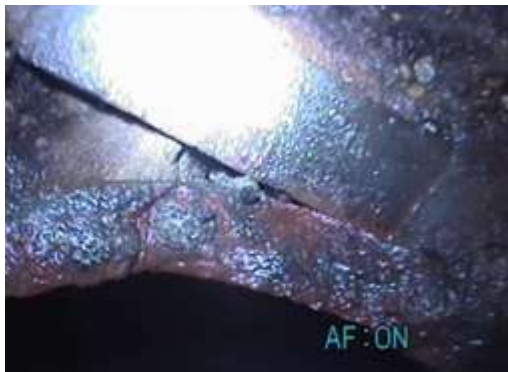
Defect 4

Crack and missing mortar above I4

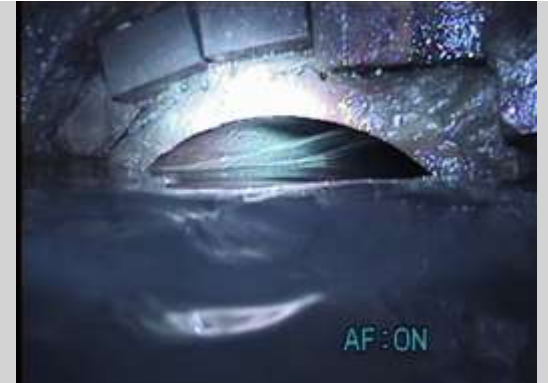
12 O'Clock Outflow

Pipe Height: **15.6** (in.) Rod and Bar (Angled)
Pipe Material: **Clay** ☐ Pipe Lined
Invert Depth: **24.00** (ft.) Flow Characteristics: **Slow**
Deposits: ☐ None ☒ **Mud** ☒ **Sludge** ☐ **Debris** ☒ **Grease**
Silt Depth: **10** (in.) Deposits Extent: **Heavy**
Infiltration: **Evidence** Pipe Seal Cond: **Cracked**

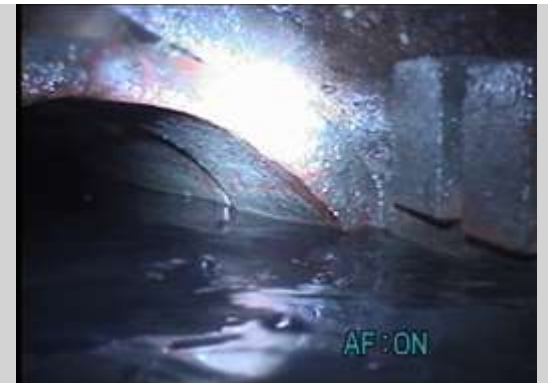
4 O'Clock Inflow

Pipe Height: **15.6** (in.) Rod and Bar (Angled)
Pipe Material: **Clay** ☐ Pipe Lined
Invert Depth: **23.75** (ft.) Flow Characteristics: **Slow**
Deposits: ☐ None ☒ **Mud** ☒ **Sludge** ☒ **Debris** ☐ **Grease**
Silt Depth: **10** (in.) Deposits Extent: **Heavy**
Infiltration: **Evidence** Pipe Seal Cond: **Cracked**
